Landslides (2013) 10:409–420
 DOI 10.1007/s10346-012-0329-5
 Received: 25 February 2011
 Accepted: 4 April 2012
 Published online: 22 May 2012
 © The Author(s) 2012. This article is
 published with open access at
 Springerlink.com

Riccardo Fanti · Giovanni Gigli · Luca Lombardi · Deodato Tapete · Paolo Canuti

Terrestrial laser scanning for rockfall stability analysis in the cultural heritage site of Pitigliano (Italy)

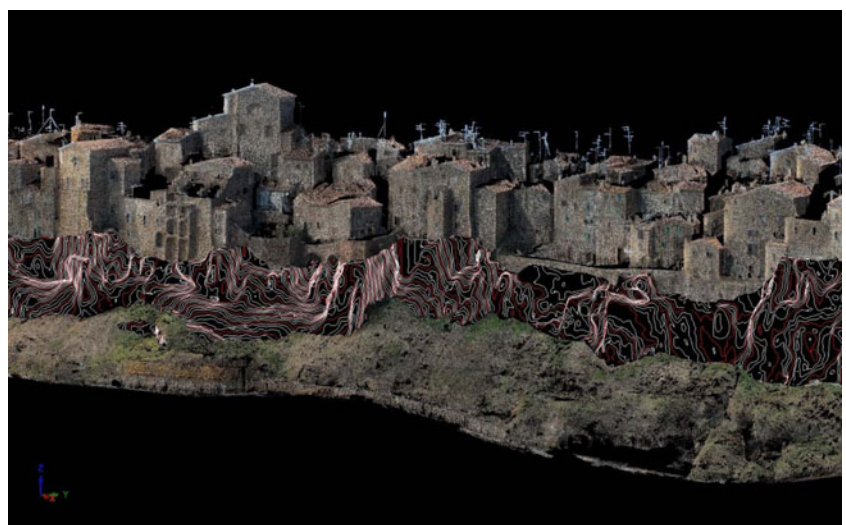
Fig. 8 True coloured point cloud of the southern side of the Pitigliano cliff; *contour line* representation highlights morphologic features of the outcropping rock mass
